How we saved a Generator (in fact two), again!

Background

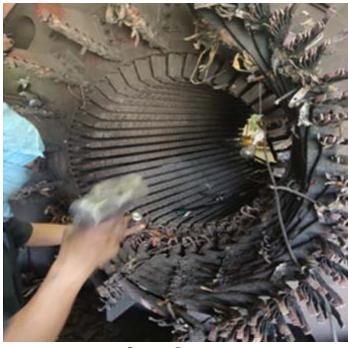
- And then came the moment of reckoning, and you know from where? NCT wiring was the culprit for the Generator burn-out! Least expected fault for a Protection Engineer so to speak (It was found while carrying out Stator Earth Fault scheme checking).
- Following actual images clearly show the fault. So, 90 % Stator Earth Fault Protection (51S) did not operate due to non-wiring of NCT secondary S2 to Relay. Generator kept running on this serious a fault which finally led to heating and eventually, NPS operation operated on time delay. But by the time NPS operated, the damage was already done.

Stator Burnt

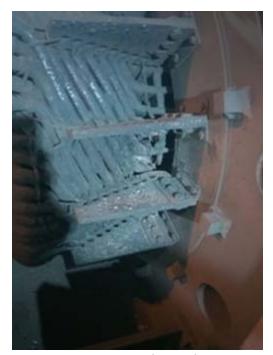
Disconnected Winding
