How a tiny piece of Aluminium tape caused a Plant Stoppage

Background

The incident happened on March 10th, 2020, on Holi/Dhuleti day.

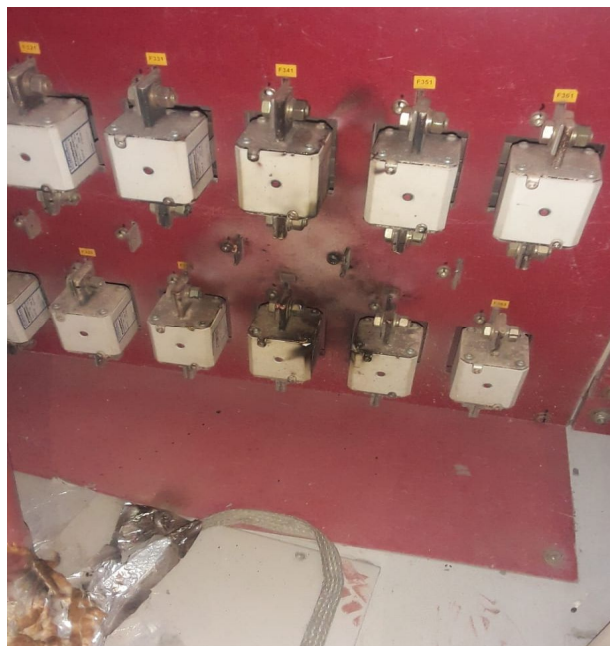
When the team reached the incident site, the inside of the MV Drive Panel is found as shown in the picture :

We can observe a flash-over across a fuse and some carbonisation nearby. This flash-over caused the MV VFD drive to trip, which eventually led to complete stoppage.

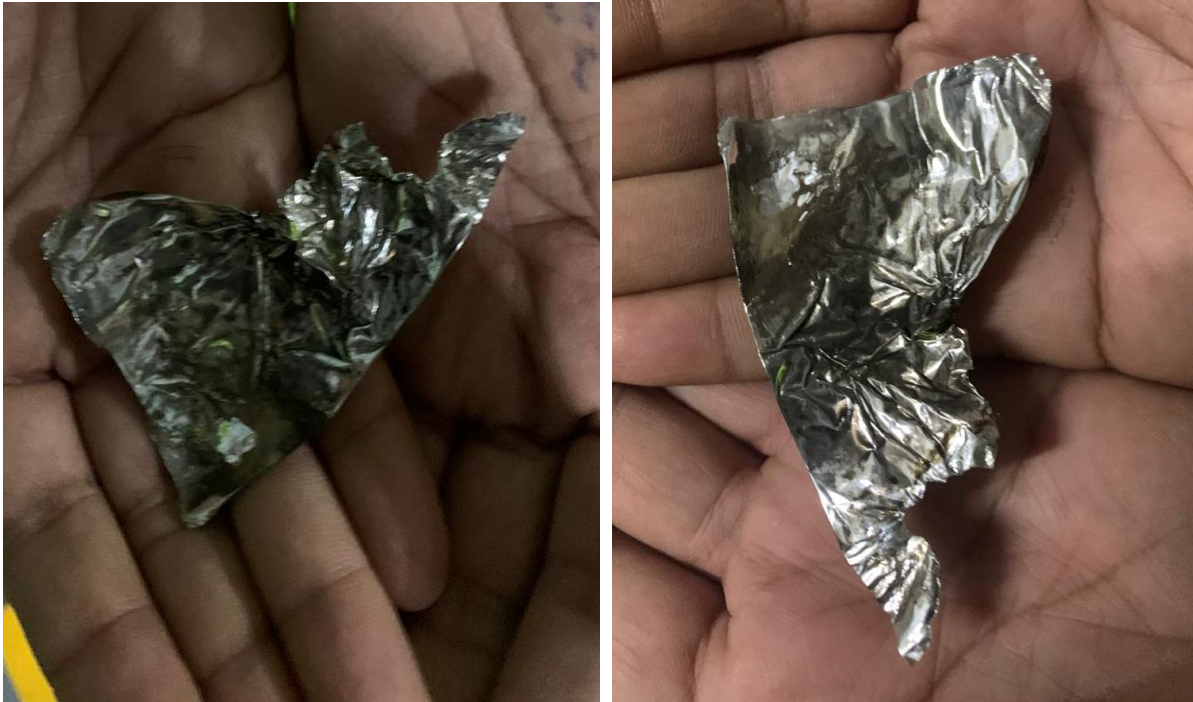
But what caused the flash-over? Upon investigating, it was found that it was caused by a stray piece of aluminium tape, actual photograph of the same is shown below.

- The subject MV VFD Drive was for 2750 kW, 6.6 kV Motor, having 4 Nos. of 3.7 kW fans for cooling inside the Drive Panel Compartment.
- These cooling fans blow the air from inside of the Panel to outside to keep the Drive cool. In the process, a negative pressure is always present in the panel, meaning, it sucks the hot air from inside along with dust particles if any, and throws it out.
- Now the Aluminium tape, which is normally used to close unused/blank holes in panel (to prevent ingress/vermin-proofing), was pasted in this Panel from INSIDE. Over a period, the glue-strength deteriorated, tape came out, and due to negative pressure present in the panel compartment, the tape came in contact across the fuse which caused the flash-over.

- Wherever possible, Blank/unused holes or open spaces are to be vermin-proofed from OUTSIDE.

- The use of non-conducting material such as puff-seal, is to be encouraged.
- While applying tapes, the surface is to be cleaned properly and tapes used should be of good adhesive quality.
- We all know that despite taking all such measures, accidents happen and almost all electrical accidents result in Fire. To minimise the damage through Fire in Electrical Panels, we can use **Fire Detection and Suppression system**. To know more, call/write to us.
