## **Case Study – How Vigilant Electrical Maintenance team saved a Power Transformer**

A **31.5 MVA, 66/11 kV Power Transformer** was part of a power distribution system supplying utilities through an 11 kV switchgear. The plant had three identical transformers, all kept in charged condition. However, the 1st and 3rd transformers were heavily loaded, while the 2nd transformer was primarily used as a standby unit.

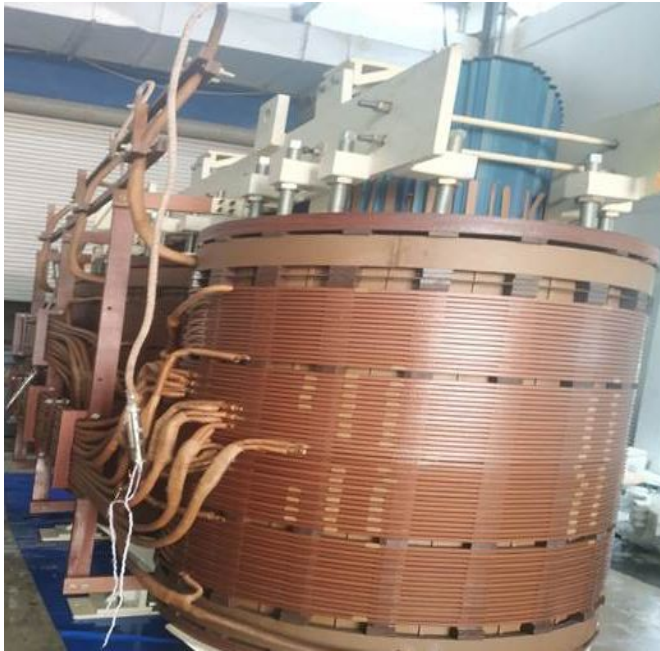
**CCA OF THE SAID TRANSFORMER**

While conducting Insulation resistance test the voltage is notwithstanding/ building up normally, all of a sudden, the team noticed some chattering sound from inside the transformer, all the team members were inspecting the transformer from all three sides of inspection window, but the chattering sound/ spark is not accurately visible.

The core has been lifted from the body and visual inspection performed, no abnormalities found, IR between core & yoke frame conducted @ 2500 volts, chattering sound observed.

Finally, the case was concluded, one washer found resting on the bottom of a center limb of core and touching the yoke frame resulting in sparking/chattering.

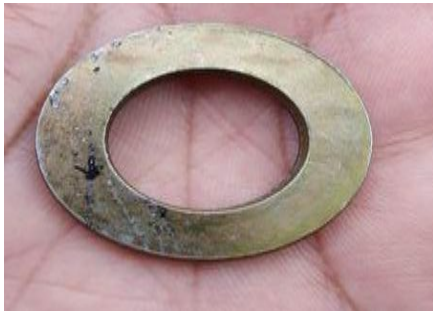
**Pic of the washer which was resting in the bottom of the center limb.**

At this stage, it is difficult to determine the exact point of entry. The washer could have made its way inside the transformer either during manufacturing at the OEM facility or during installation at the site. While it may appear to be sheer negligence or poor workmanship, such incidents, though rare, can occur.

Upon removal of the washer, an IR test was conducted, yielding values exceeding 500 Mega-ohms, confirming the integrity of the insulation. Following this, the transformer was repacked, subjected to thorough testing, and found to be in optimal condition. With everything performing as expected, it was successfully commissioned and is now in service.

1. Upon transformer receipt, always check the insulation resistance of the core and yoke frame earthing points individually against the ground/body.
2. If these points are not externally accessible, remove the manhole cover, isolate all three points, and conduct an insulation resistance test.
3. Conduct DGA testing at key intervals: before charging, after 24 hours of no-load operation, under full load after 24 hours, and again after a month (if online DGA is unavailable).
4. If oil test/DGA reports are outside prescribed limits, verify results with at least one NABL-accredited lab before concluding.
5. During transformer erection and accessory installation, ensure strict material handling protocols. Double-check that no foreign objects fall inside the transformer tank before sealing and oil filtration/charging.
