## Case Study – Unlocking Transformer Secrets: Diagnostic Testing Uncovers Hidden Damage

Details of Transformer under Test : **Rating : 31.5 MVA, Voltage : 33 / 11.5 kV**

Tap Changer : OLTC, Year of Mfg. : 2008

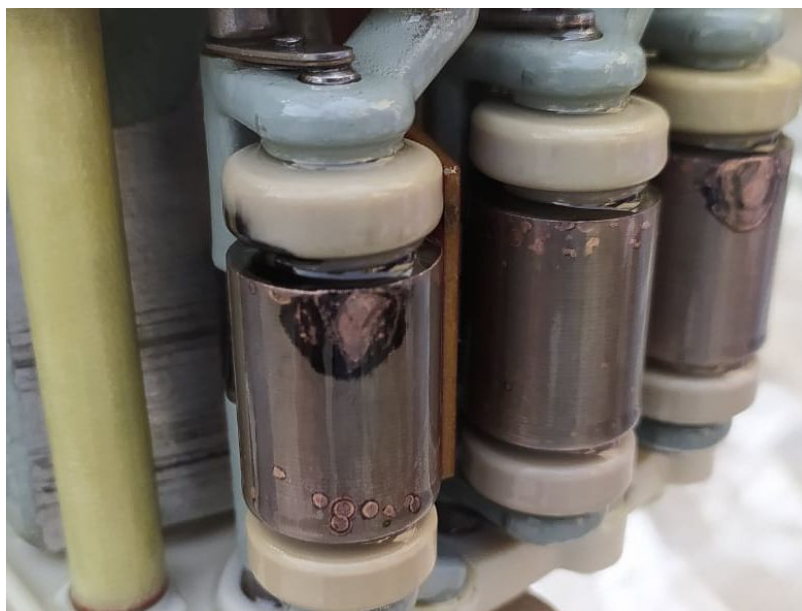
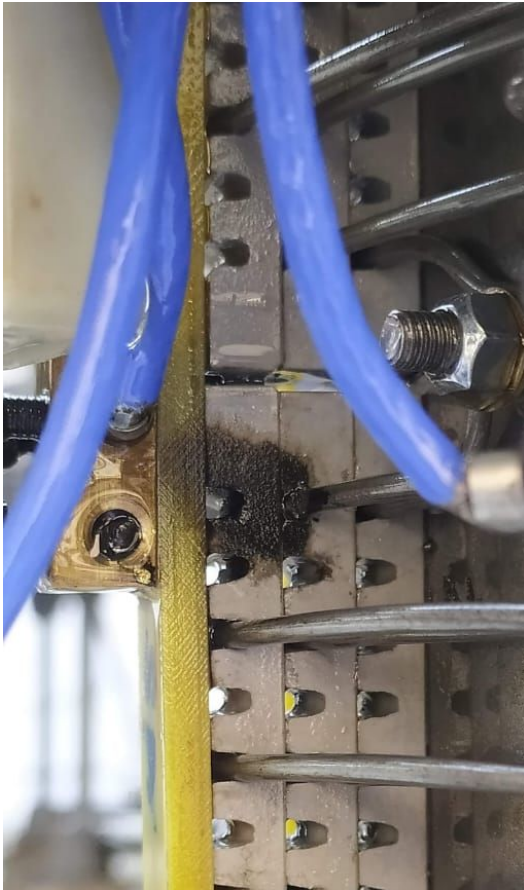
- Dynamic Resistance Measurement showed bad contacts and transition Resistor.
- This Pattern was observed while Moving upwards and Downwards.
- Again, a Single Tap position was used two times during up or down sequence.
- This indicated that there were some problems in OLTC itself.
- OLTC was opened and Contacts were observed.
- Transition resistance showed sparking.
- Pitting was also observed on Moving contacts.

Above are the images of unhealthy OLTC moving contacts and transition resistor

- **Continuous operation:** When the grid voltage is not stable OLTC keeps on operating manier times to maintain the same and can say work Overtime, the OLTC's contacts can wear down, loosen, or become misaligned, leading to increased resistance during tap changes.
- **Overheating:** Excessive heat within the transformer can degrade the contact surfaces of the OLTC, increasing resistance and potentially causing arcing.
- There can be few others too, but that can be confirmed on case to case basis.

Armed with this crucial information, the Maintenance team was able to take proactive actions for the Overhauling of OLTC. By proactively addressing the hidden issues within the OLTC, they prevented a potential catastrophe. This ensured continued operation, and avoided the high costs associated with an outage.
