Case Study – How hidden issues are Threatening your Transformers

Details of Transformer under Test: UT **Rating: 45 MVA, Voltage: 20/11 kV**, Tap Changer: OLTC, Year of Mfg.: 2009

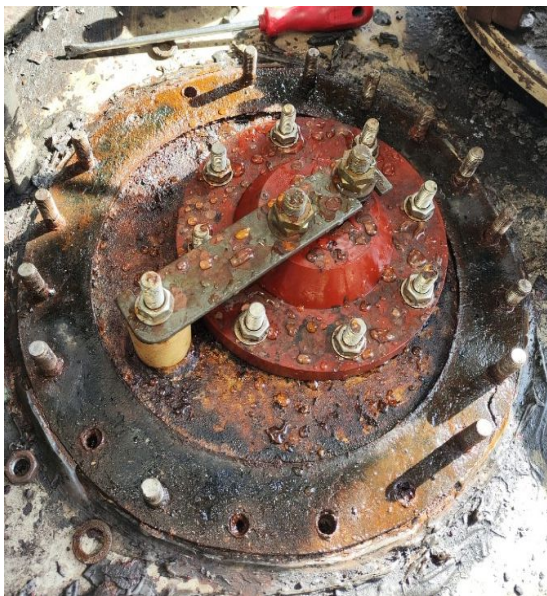
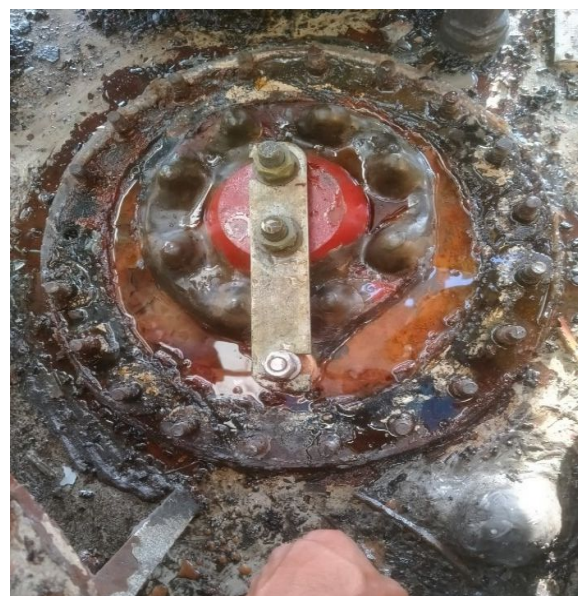
RUSTED CFT CONNECTIONS

- From the above image you can see that the CFT components were found to be heavily rusted and moisture-affected.
- The rusted CFT connections were carefully removed, and both the contacts and plates were thoroughly cleaned.
- A subsequent DFRA test was conducted after the cleaning process.
- This time, the transformer's moisture levels were well within the acceptable limits.

- **Moisture Accumulation in the CFT Box:** Over time, repeated heating cycles of the transformer, especially during monsoon and winter seasons, can lead to vaporization within the CFT terminal box, causing moisture buildup.
- **Improper Sealing:** The absence or inadequate use of proper sealant in the CFT box can allow moisture ingress, further contributing to insulation degradation.
- **Additional Factors:** Other contributing factors may vary on a case-to-case basis and require further investigation to confirm.

- **Pre-Monsoon Preventive Maintenance:** Conduct thorough inspections and maintenance before the monsoon season to prevent moisture-related issues.
- **Proper Sealing:** Ensure effective sealing of critical components, including the CFT terminal box, marshalling box, CT terminal box, and both HV & LV terminal boxes, to prevent moisture ingress.

- **Regular Inspection & Cleaning:** Every six months or whenever shutdown permits, open the CFT terminal box for proper cleaning and perform an IR test to assess insulation health.

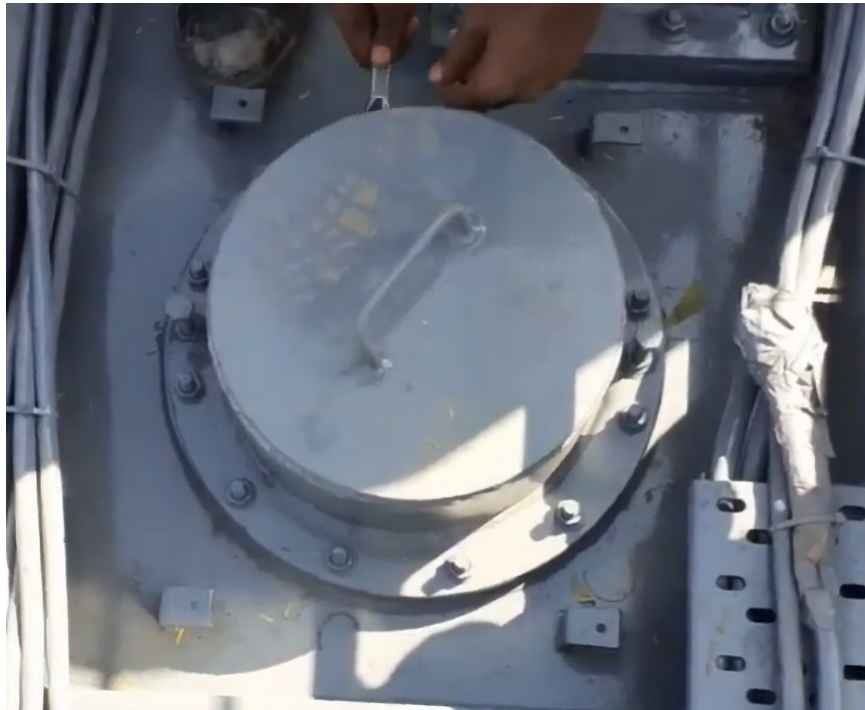
This is how a CFT before Opening Looks like on top of Transformer
